## Nuclear reactor maintenance

In late 2003 Ringhals AB asked companies to tender to repair a section of pipe in Ringhals 1. Ringhals 1 is an 830Mw ABB-Atom Boiling Water Reactor located on the west coast of Sweden, south of Gothenburg. Tenders were submitted in mid-January 2004 and the contract was placed just 2 weeks later.

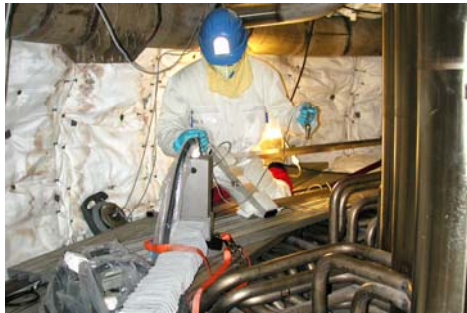
In Ringhals one of the systems of primary importance is the series of 157 control rod drive mechanism (CRDM) pipes that are welded to the bottom of the reactor vessel. These pipes hold the control rods which are driven up and down to maintain a stable nuclear reaction. Each of these

157 CRDM pipes has an associated smaller diameter pipe, called a SCRAM pipe<sup>1</sup>. In a reactor trip, high pressure water is pumped through these smaller pipes forcing the control rods up into the reactor vessels and shutting down the nuclear reaction. The correct operation of these pipes and the control rods is therefore critical to the safe operation of the reactor.

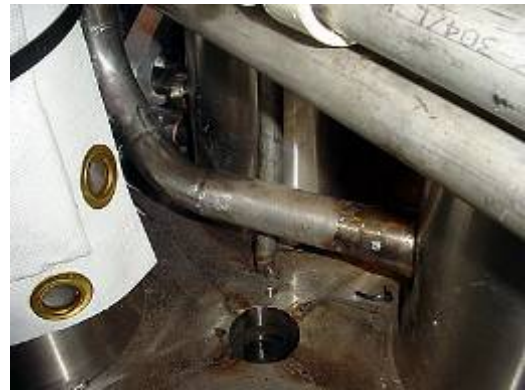
**OC**Robotics proposed two robots that were unimaginatively called the Manipulation Arm and the Inspection Arm. The Manipulation Arm gained access through the Jungle reaching along the available 90mm wide corridor and then down and around some other pipes to SCRAM nozzle. The Inspection Arm was designed to snake through the 62mm diameter holes in the floor of the Jungle and around a CRDM pipe to the SCRAM nozzle.

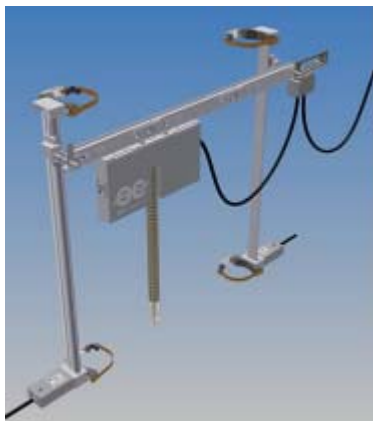
The image to the right shows a CAD model of the complete Manipulation Arm. This was the arm that gained access from within the Jungle by passing between adjacent rows of CRDM pipes. The widest part of the design was the 82mm wide Manipulation Arm Box which contained the drive mechanisms for the snake-arm. The arm itself is 60mm in diameter and 800mm long. The arm has 8 degrees of freedom with a further 3 degrees of freedom available within a wire driven wrist which has the same outer diameter. The arm and wrist axes are controlled by 16 motors and actuators located within the Manipulation Arm Box. This box is itself suspended on a rail on the underside of a horizontal beam. The beam was made in modular sections for ease of installation and to

cope with the different corridor lengths. The longest beam required would be 6m. The Manipulation Arm Box moves along the beam using a friction drive driven by a motor and actuator within the Manipulation Arm Box. Completing the system, the beam is suspended between two coupled vertical axes that lower the snake towards the work site. These vertical axes were secured to the end CRDM pipes of each row of CRDM pipes. The Manipulation Arm Box is a completely sealed box with a separate sealed channel for services that leads directly into the

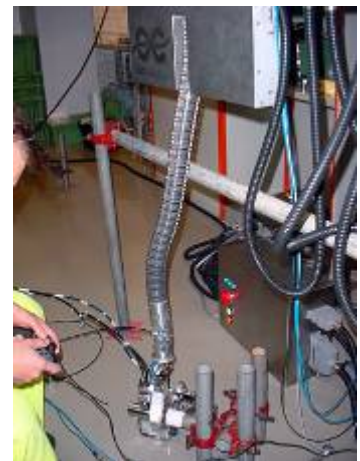
The image on the right shows an operator driving the Manipulation Arm. The horizontal scaffolding pipe represented the top of a stack of SCRAM pipes that had to be avoided. The operator is practising moving the fixtures into place around a dummy pipe. The operator has better than 50 micron motion resolution of any tools or fixtures and is able to drive with respect to the pipe coordinate frame in Cartesian space. Computer controlled motion resolution (e.g. point to point) is better than 20 microns.

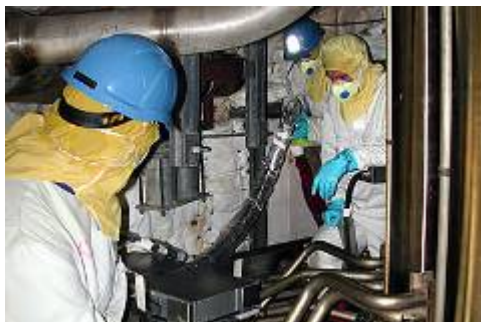
Once the operators became familiar with the basic operation of the Manipulation Arm it was disassembled and re-assembled in a purpose built mock-up of the real environment. One of the conditions of being able to use equipment within a reactor is to conduct fully representative Factory or/and Site Acceptance Tests. The image on the right shows the partial representation of the CRDM pipes and the Manipulation Arm Box in position with the snake-arm starting to reach down to the worksite. Follow-the-nose motion is achieved by coordinating the motion of the two vertical axes with the snake-arm motion.

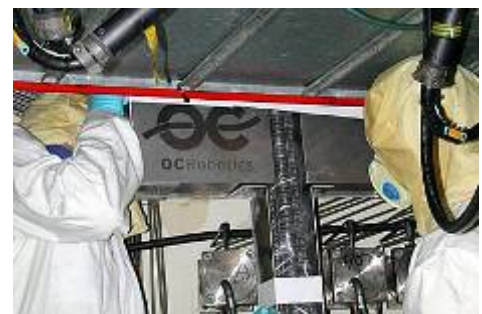
The photo above shows the Manipulation Arm in the space around the CRDM pipes. A few SCRAM pipes are visible in the bottom right of the photograph. The photo on the right shows the Manipulation Arm fully assembled prior to

moving along the corridor to the work site. The snake-arm had to be introduced in a bent configuration to avoid a variety of ‘other’ pipes that restricted access. The arm was then straightened once it was in the working corridor. Following the trial installation and operation the Manipulation Arm was decontaminated and taken back to the mock-up to complete the Acceptance Tests.

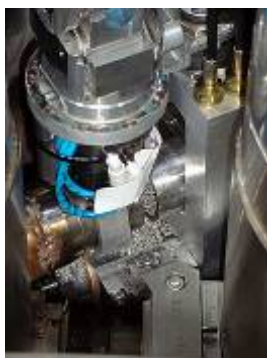
The next phase involved delivering and locating a weld prep cutting tool which was used to reshape the outer surfaces of the cut pipe in preparation for the new pipe. This was one of the most demanding tasks due to the precise fit between the cutting tool and the cutting machine spindle.

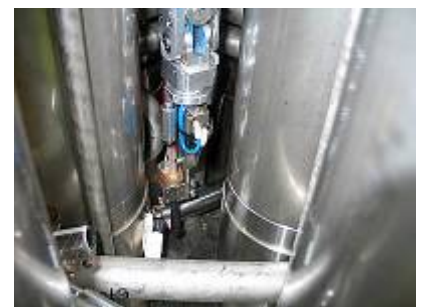
This then secured the new pipe in position and enabled the mandrel to be removed to allow the parent metal welding process to begin. The Manipulation Arm was then used to place a gas shield around the new pipe to prevent oxidation of the weld.
