Snaking around in a nuclear jungle

Rob Buckingham and Andrew Graham
OCRobotics, Henleaze, Bristol, UK

Purpose – The paper describes a pipe repair conducted in August 2004 using two types of snake-arm robot. The pipe was located 5m below the reactor core of Ringhals 1 nuclear reactor.

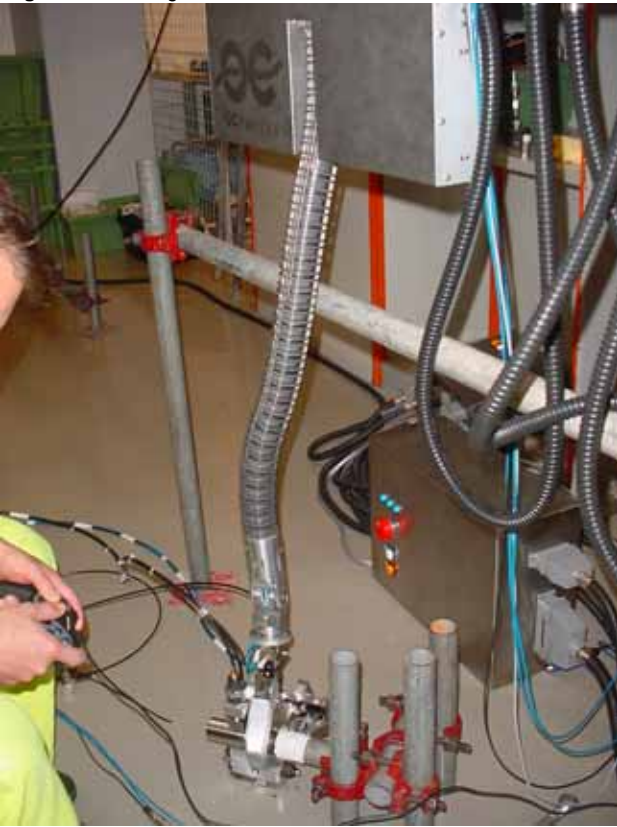
Figure 4 – Training with the Overhead Arm

Figure 4 shows an operator driving the Overhead Arm. The horizontal scaffolding pipe represented the top of a stack of SCRAM pipes that had to be avoided. The operator is practising moving the fixtures into place around a dummy pipe. The operator has better than 50 micron motion resolution of any tools or fixtures and is able to drive with respect to the pipe coordinate frame in Cartesian space. Computer controlled motion resolution (e.g. point to point) is better than 20 microns.

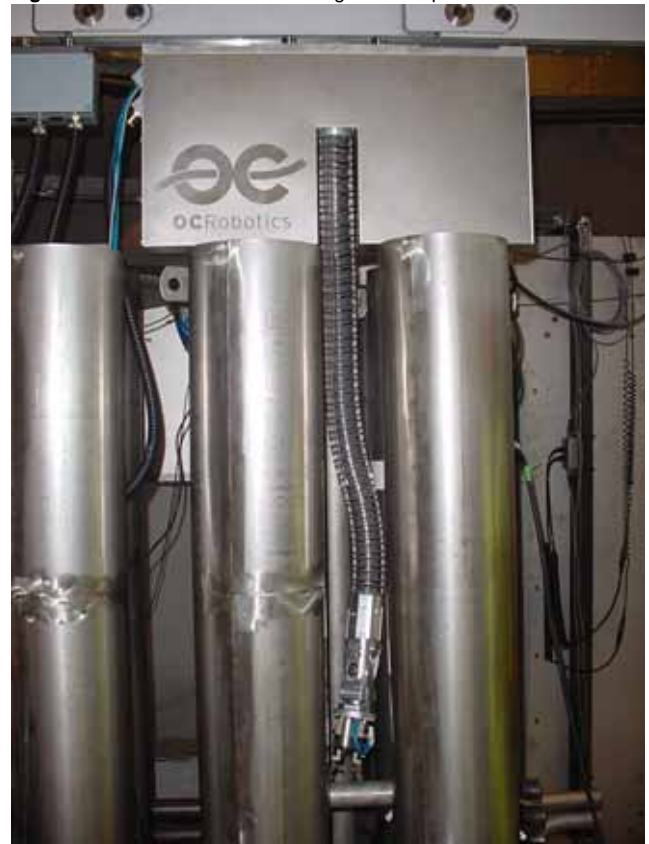
Figure 5 – Overhead Arm in the Jungle mock-up.

equipment within a reactor is to conduct fully representative Factory or/and Site Acceptance Tests. Figure 7 shows the partial representation of the CRDM pipes and the OA Box in position with the snake-arm starting to reach down to the worksite. Follow-the-nose motion is achieved by coordinating the motion of the two vertical axes with the snake-arm motion.

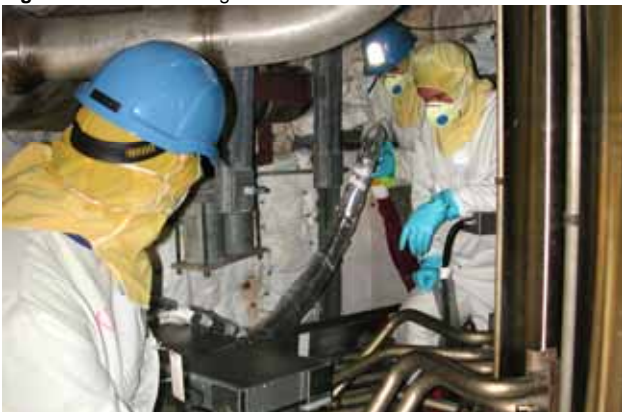
Figure 7 - OA in the Jungle Room.

Figure 7 shows the OA in the space around the CRDM pipes. A few SCRAM pipes are visible in the bottom right of the photograph. Figure 8 show the OA fully assembled prior to moving along the corridor to the work site. The snake-arm had to be introduced in a bent configuration to avoid a variety of 'other' pipes that restricted access. The arm was then straightened once it was in the working corridor. Following the trial installation and operation the OA was decontaminated and taken back to the mock-up to complete the Acceptance Tests.

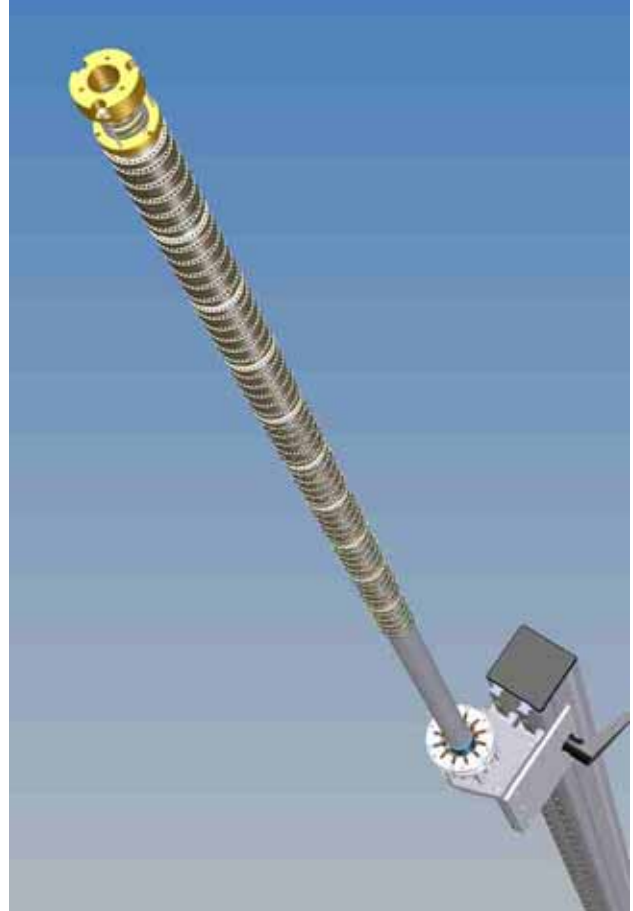
Figure 9 – The slender arm of the Underneath Arm

The second arm supplied by OCRobotics was called the Underneath Arm (UA), **Figure 9**. The UA was designed to stand on the floor of the room below the Jungle. The complete robot when fully extended stands 4m tall. The UA was actually designed for a longer arm with a 60mm diameter arm and a payload of 10kg but due to shifting specifications the final arm was 35mm in diameter with a payload of 500g.

The Underneath Arm is the more snake-like of the two – with 10 segments and a total of 23 degrees of freedom including a 2 axis wrist. The task of this arm was to introduce cameras around the back of the CRDM pipes to gain a close-up view of the worksite.

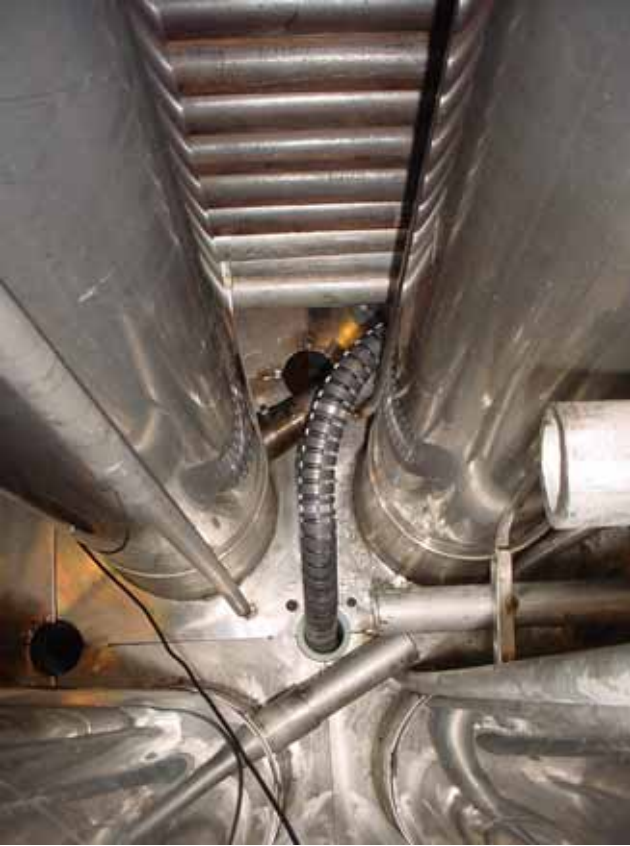
Figure 10 - UA in position

Figure 12 shows the UA gaining access through one of the 62mm diameter holes in the Jungle floor and then reaching around the back of the CRDM pipe. Figure 11 shows the head of the snake with its two differently fixed focal length cameras pointing towards the SCRAM pipe nozzle. Figure 16 shows the view of the work site from the cameras.

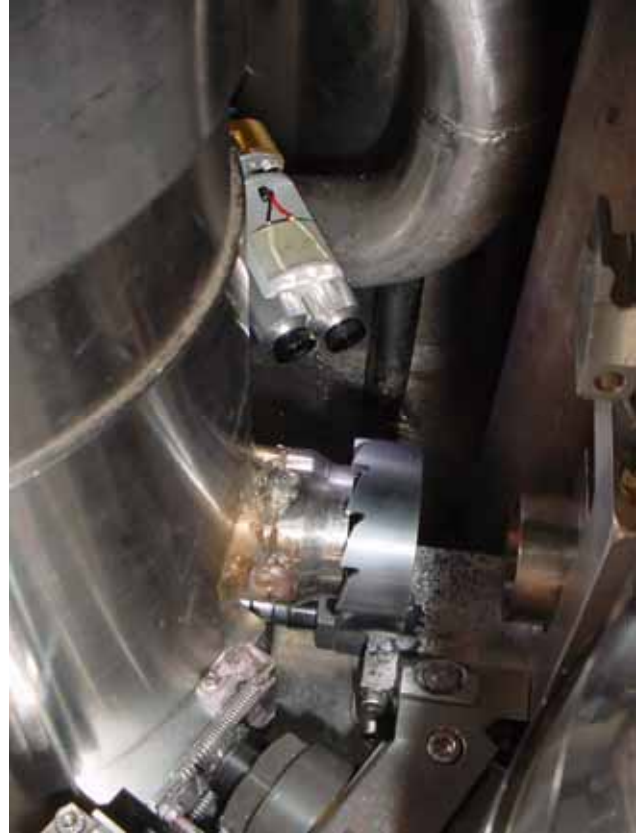
Figure 11 – UA cameras in position

By using two cameras with slightly different focal lengths the operator was provided with an excellent view of the OA wrist, gripper, fixtures and tools as they entered the work site. Whilst other cameras were mounted on the OA Beam and at the end of the OA wrist the view from these cameras was often obscured. Having an independent scene view was essential for working in such a congested environment and enabled the fully remote operation to be completed faster than achieved with the operator standing next to the mock-up and trying to peer into the jumble of pipes and fixtures.

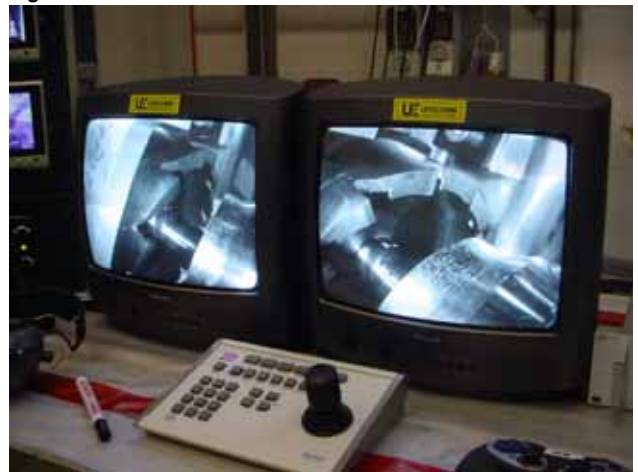
Figure 12 - View from UA cameras

The next phase involved delivering and locating a weld prep cutting tool which was used to reshape the outer surfaces of the cut pipe in preparation for the new pipe. This was one of the most demanding tasks due to the precise fit between the cutting tool and the cutting machine spindle, Figure 12.
